# Crime scene investigation and dynamic reconstruction: importance of synergic collaboration between forensic pathology and digital reconstruction for work-related fatalities

*Soud Lek 2021; 66(1): 2–5*

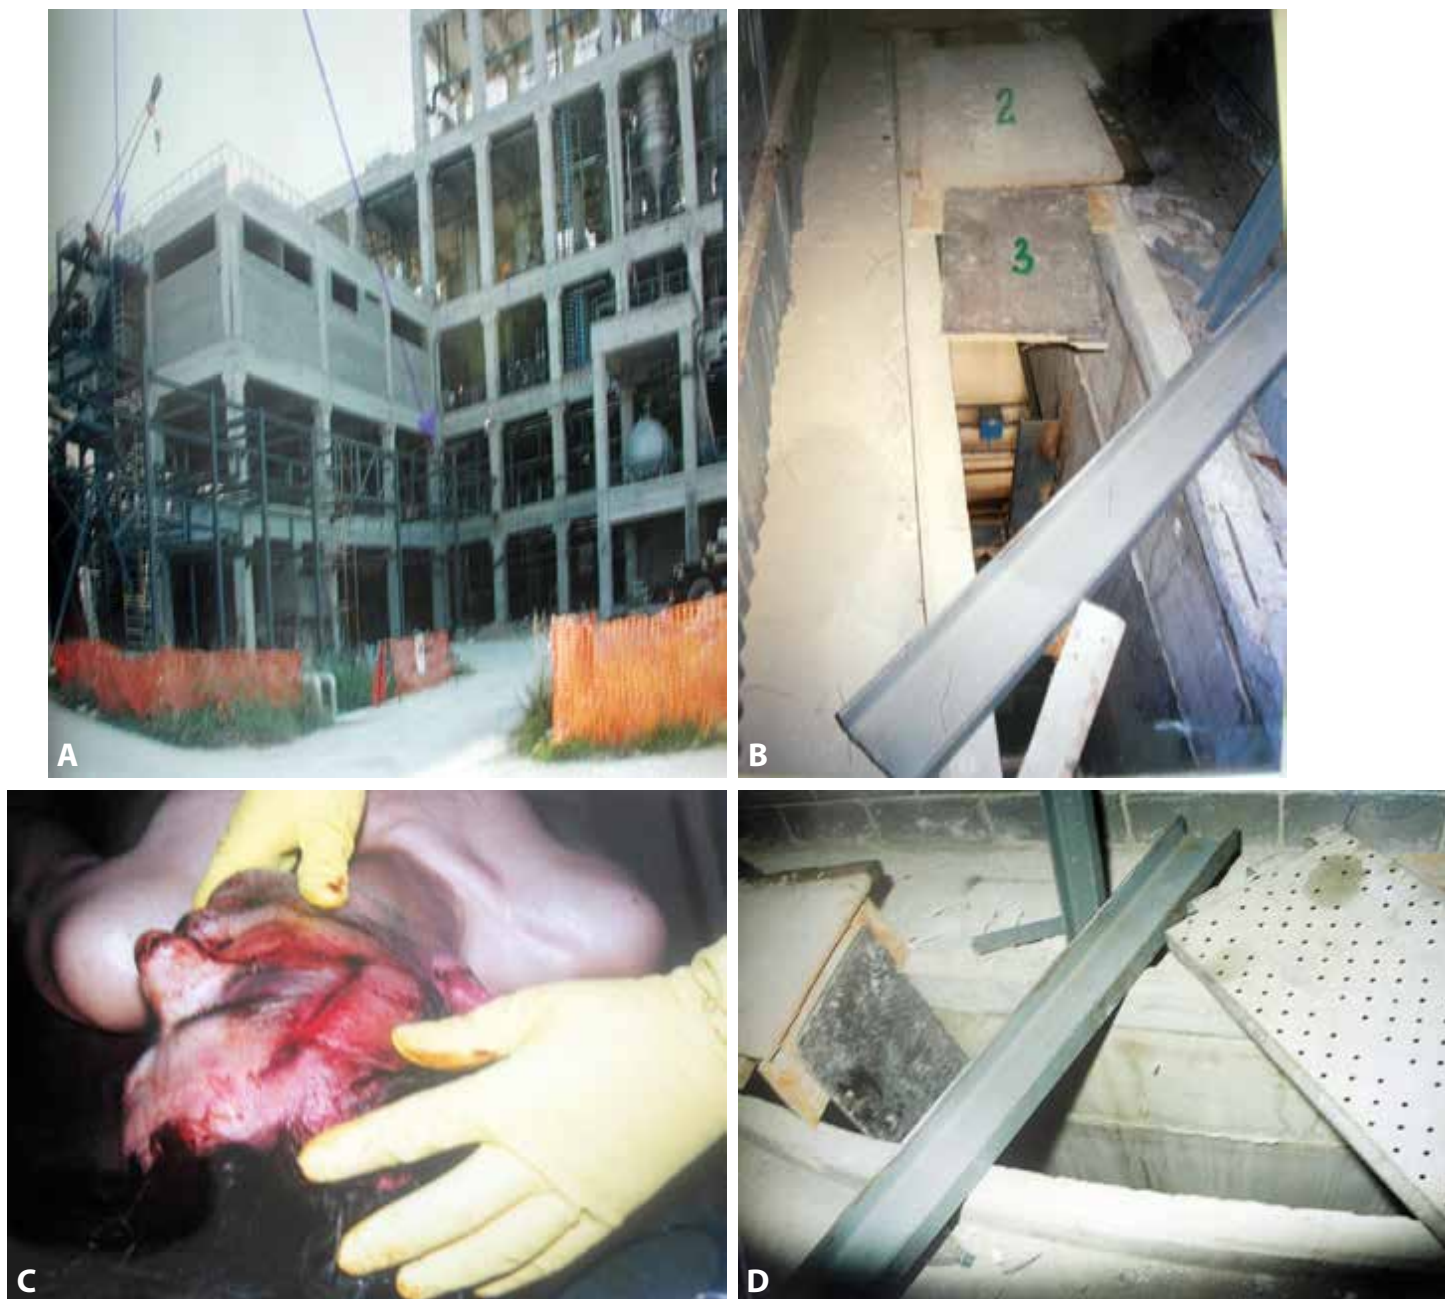
**Figure 1. A, B, D:** building where the accident took place. **C:** linear laceration involving the skin and subcutaneous tissues, 8 cm long, in the right frontal-zygomatic region.

was sufficiently wide to allow equipment to be transferred between the floors. Some wooden planks had also fallen together with the worker. No one heard the first worker crying out as he fell (Figure 1A, B, D).

A judicial inquiry was initiated to assess the cause of death and the employer's liability. The corpse was 166 cm in length and 75 kg in weight. During the autopsy, the following lesions were found: (a) a linear laceration involving the skin and subcutaneous tissues, 8 cm long, in the right frontal-zygomatic region, with a cranio-caudal course inscribed within a wider ecchymotic area, which included the latero-orbital region and expanded toward the ipsilateral temporal region (Figure 1C); (b) thick fractures at the parietal and right temporal squares, extending to a larger fracture in the anterior cranial fossa and right middle cranial fossa, where traumatic decay of the right petrous ridge and mastoid was evident; (c) deep abrasion, with an almost ellipsoidal shape, to the right patellar lateral surface and two ecchymotic areas at the level of the distal third of the thigh and of
